# HOT SALT STRESS CORROSION OF TITANIUM ALLOYS IN AN ADJUSTABLE DEFLECTION, MULTI-SPECIMEN BENT BEAM TEST APPARATUS

ANTHONY K. WONG and MILTON LEVY

March 1973

ARMY MATERIALS AND MECHANICS RESEARCH CENTER  
Watertown, Massachusetts 02172

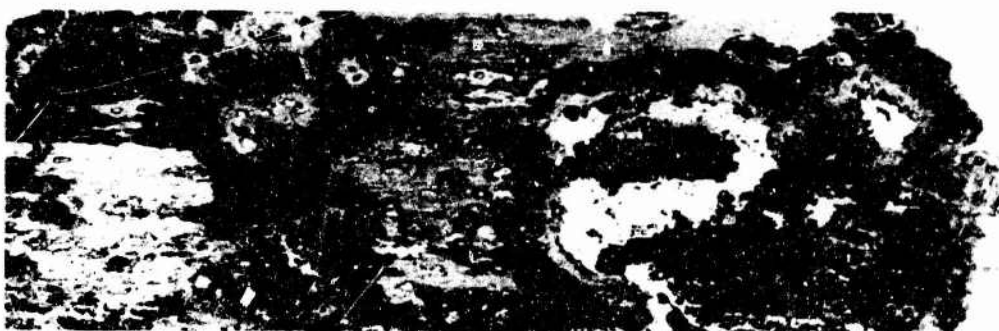
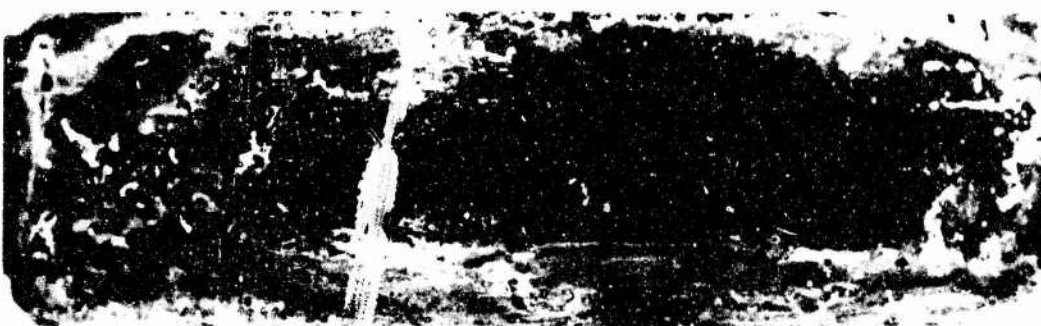
a. (A3) UNTREATED CONTROL

b. (A2) SALT-TREATED

c. (A4) SALT-TREATED

Figure 3. Test Series I - (900°F - 150 Hours) - Central Test Section of  
Longitudinal Specimens After Removal from Furnace (X5)  
19-066-142 MC-72

Constant deflection bend test specimens were removed from the test fixture after exposure to 900°F for 150, 500 and 1000 hours as required by the test plan. Generally, the oxidation and salt reaction products on the surface masked the damage on the surfaces. Representative of this phenomenon were three of the specimens tested in Series I after exposure for 150 hours, as shown by the photomacrographs (5x) in Figure 3. These photographic enlargements show the appearance of the central sections of one non-salt-treated and two salt-treated titanium specimens.

Although not apparent in the photograph, the surface of the untreated (no-salt) specimen was covered with a typically smooth oxidation coating in various shades of blue, purple, and straw. Moreover, the surface was obviously striated in the direction of the length of the specimen, as shown in Figure 3a. As mentioned previously, this series of specimens was cut from sheets with the specimen length parallel to the direction of rolling.

Islands of white on the temperature-exposed, salt-treated specimens appeared, under higher magnification, to be composed of conglomerated crystals

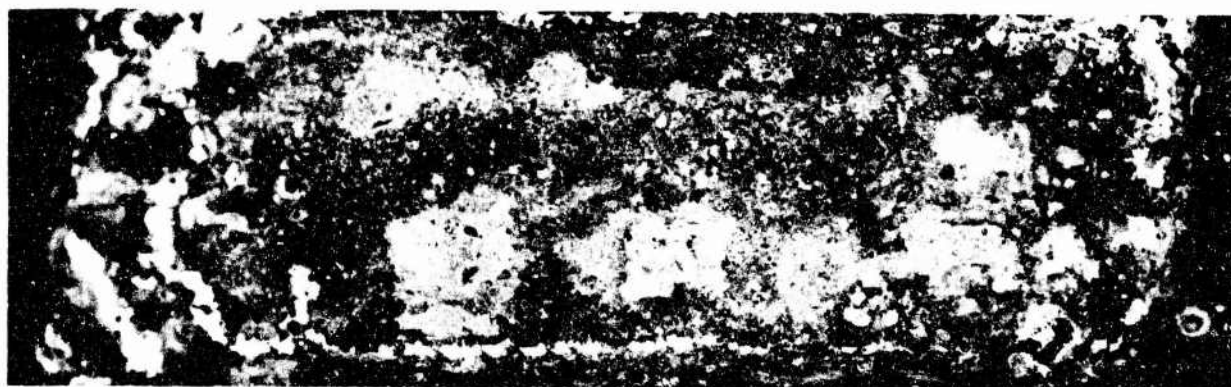
Figure 5. Test Series V - (900°F - 1000 Hours) - Salt-Treated  
Longitudinal Specimens After Removal from Furnace (X5)  
19-066-1425/AMC-72

After removal from the furnace, agglomerations of white salt crystals were observed to be present on the surface of the specimens even after exposures up to 1000 hours, as shown by the duplicate specimens in Figure 5. Similar appearances were also exhibited by the specimens exposed for only 150 hours and shown earlier in Figures 3b, 3c, and 4b. The locations and sizes of the islands of white substance were closely related to the wettability of the original surface by the saline solution.

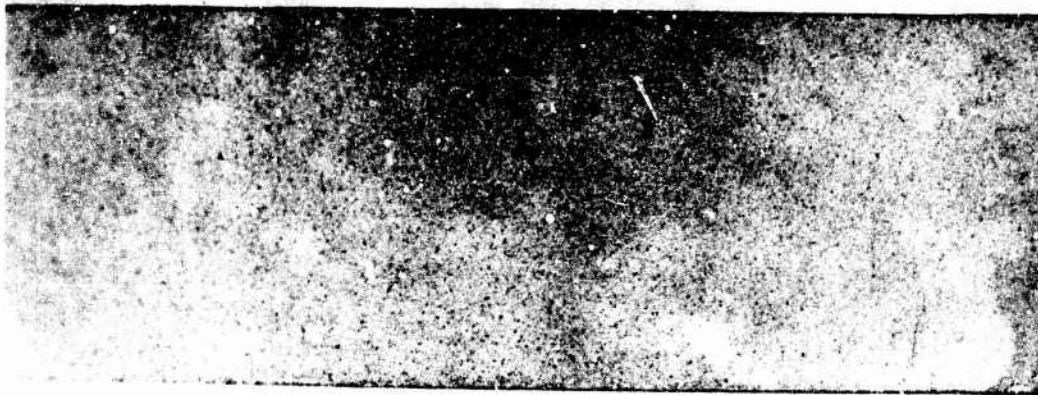
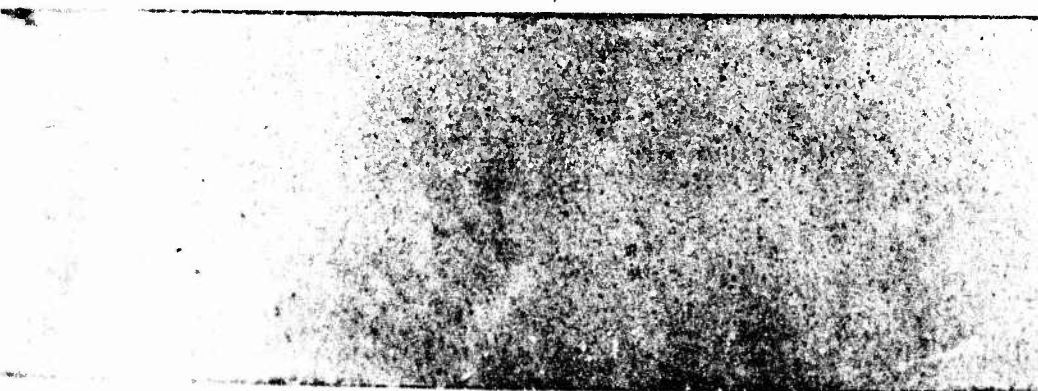
Figure 6. Test Series V - (900°F - 1000 Hours) - Salt-Treated Specimens  
Cleaned by Wet Abrasive Blast Method  
19-066-1426/AMC-72

The wet abrasive blast cleaning method employed to remove the previously mentioned corrosion products was adequate for revealing the presence of pitting and incipient cracking as exhibited in the photographs of paired, salt-treated specimens from Test Series V in Figure 6. In the 2x magnification photographs, the relative severity of the pitting was clearly evident. On the other hand, the presence of cracks in both the 2x and 5x magnification photographs were less well-defined.

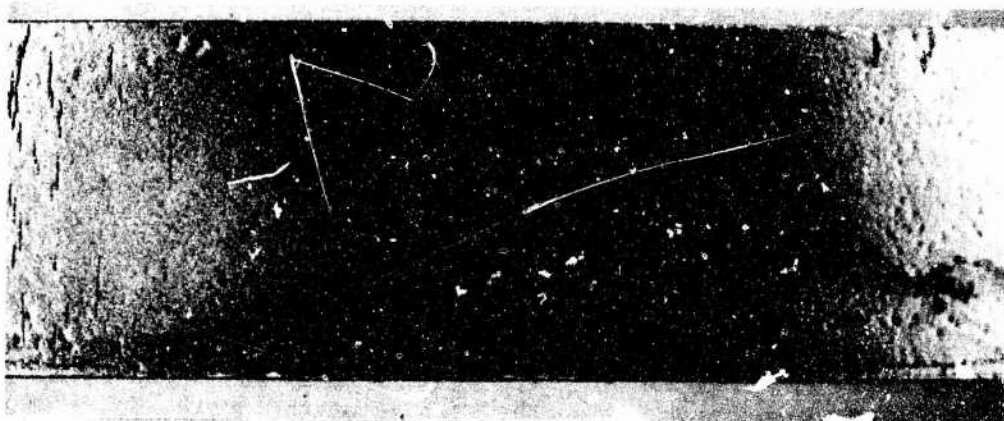
Figure 7. Test Series V - (900°F - 1000 Hours) - Etched Salt-Treated Specimens  
19-C66-1427/AMC-72

Hence, to fully assess the damage, an etchant proved necessary to fully develop the surface cracks. As shown in Figure 7, crack formation at 900°F for 1000 hours was quite severe. In contrast to Figure 6, etched specimens in Figures 7a and b explicitly exhibited multi-numbers of cracks on the surfaces which were exposed to the salt-treatment. Characteristically, the crack lengths are all positioned in a pattern arrangement perpendicular to the direction of stress.

Pits existing on the surface are more completely revealed by the 5x photographic enlargements shown in Figures 7c and 7d. It may be noted that the pits and cracks groupings coincide remarkably well with the white salt patches found on the surface of these same specimens, shown earlier in Figure 5. But the pitting and cracking phenomena appeared to occur independently as manifested by the paucity of intersection of the cracks with the pits. Nevertheless, despite the lack of interaction, the presence of corrosion pits are quite harmful since their existence decreases the volume and load carrying ability of the base metal. Furthermore, these small craters serve as focal points for the initiation of other damage due to stress corrosion and fatigue stresses.

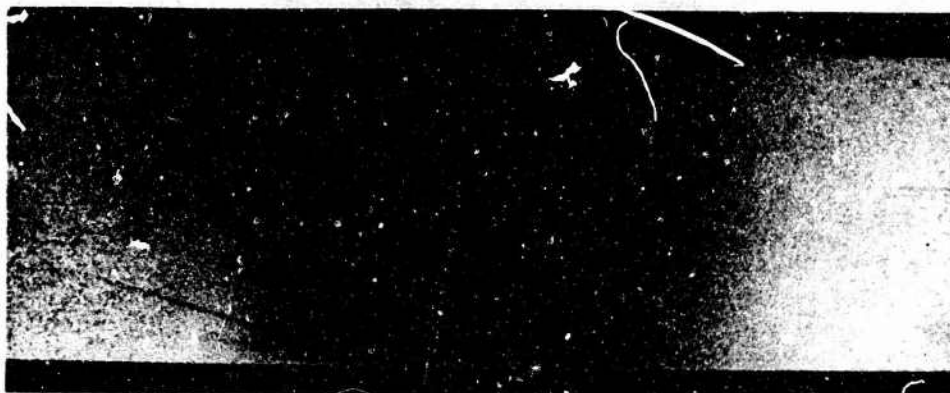
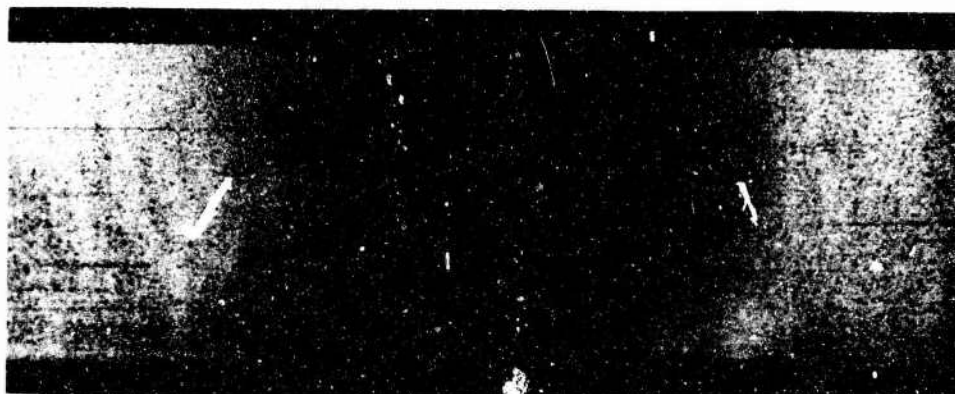
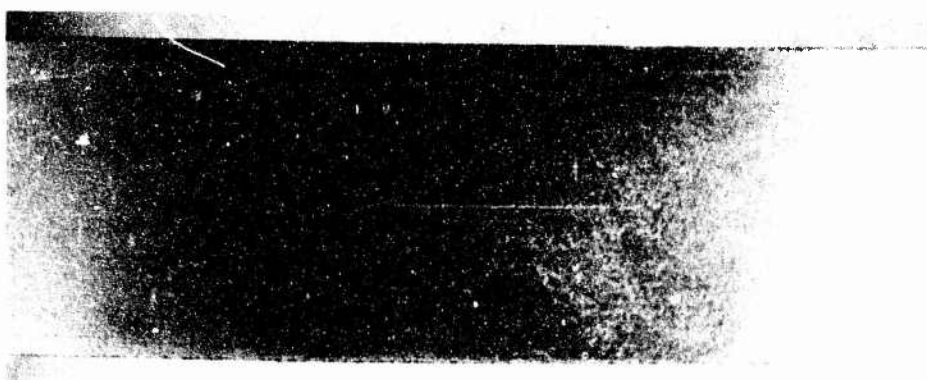
Figure 8. Etched Untreated Control Longitudinal Specimens After Exposure to 900°F Temperature (X5)

Meanwhile, inspection of the untreated control specimens, exposed to an identical test condition, revealed no damage, neither in the form of cracks nor pits, on their surfaces. Figure 8, shows the appearance of three relatively unharmed, untreated control specimens, etched after cleaning, following exposure for durations up to 1000 hours. Hence, impairment of the surface of the salt-treated specimens was directly attributable to the attendant hot salt and duration of exposure.

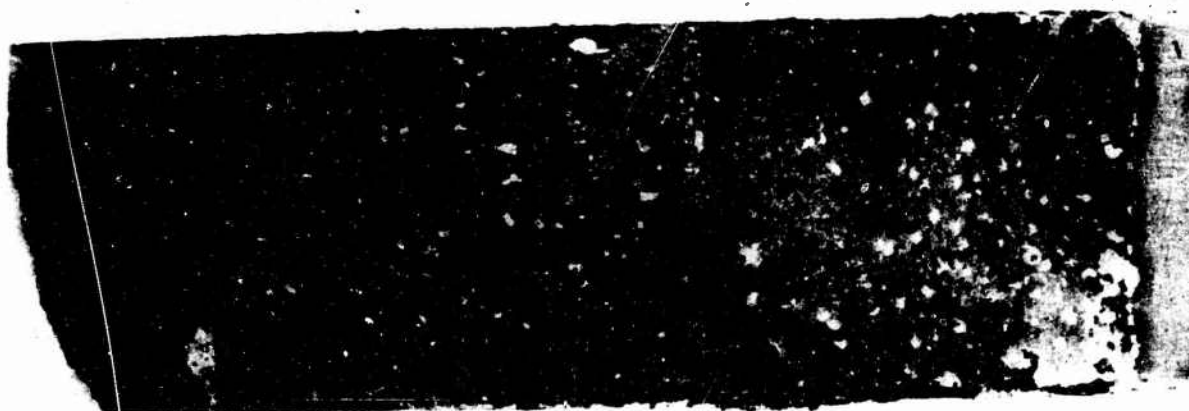
Figure 14. Test Series VII - (900°F - 500 Hours) - Salt-Treated Test Section of  
Boron Carbide Coated Specimens (X5)  
19-066-1434/AMC-72

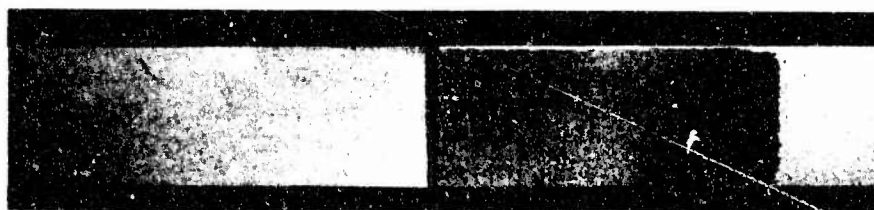
Figure 15. Test Series VII - (900°F - 150 Hours) - Salt-Treated Specimens and One Untested Coated Specimen - After Initial Exposure to Wet Abrasive Blast Treatment (X2)

But subsequent attempts to remove the black residual coating, clearly evident on the specimens in Figures 15a and 15b, by the same technique and effort which handily remove the heat-affected, non-salt-treated boron carbide coating, were not successful, attesting to greater tenacity of the reacted coating. Hence, longer durations of wet abrasive blasting of the residual coating, were required to clean the specimen surfaces. However, under these conditions, the black, adherent coating still managed to selectively protect the substrate. Thus, the removal of the black coating resulted in the generation of cratered, pocked, undercut surfaces, as shown on certain portions of the specimens photographed in Figure 16. Areas adjacent to the aforementioned segments were more uniformly cleaned by the process.

Moreover, as alluded to by the magnitude of roughened areas, the residual coating present after 150 hours was more adherent, and consequently more difficult to remove, than that remaining after 500 hours. The differences in surface roughness may be observed by comparing the 150-hour specimens shown in Figures 16a and b, with the 500-hour specimen shown in 16c. Therefore, it was also concluded that increased exposures at elevated temperatures may potentially degrade the residual coating, manifested by a decrease in tenacity.

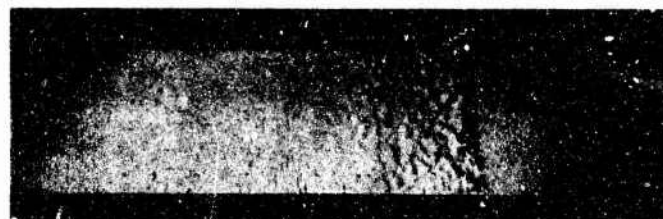
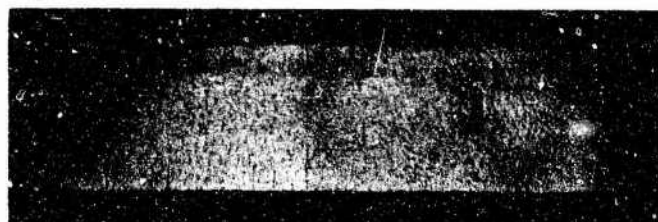
Figure 16. Test Series VI (900°F - 150 Hours) and Test Series VII -  
(900°F - 500 Hours) - Etched Salt-Treated Specimens (X2)  
19-066-1436/AMC-72

To further evaluate the efficacy of the proprietary refractory coating in retarding the debilitating effects of hot salt on titanium alloys, the substrate below the coating, along with adjacent areas, were chemically etched. As exhibited by the specimens shown in Figure 16, the test conditions were capable of generating many cracks within the salt-treated titanium alloy test segments. However, in comparison to the crack patterns described earlier in this report, the crack distributions in these coated test specimens were more uniform. This uniformity was attributed to the changes in surface cleaning techniques which enhanced the wettability of the specimen surfaces prior to the application of the saline solution.

Moreover, close scrutiny of the etched specimens also disclosed the presence of a limited number of cracks within the coating substrate area. These cracks, along with other surface phenomena, are clearly evident in Figure 17. Therein, it may be observed that the substrate cracks were few in number and confined to the edge periphery of the salt-treated coating only. It may be recalled that the coating integrity along the edges of the specimens was minimal as shown earlier in Figure 15c. Consequently, many of these edge cracks may have initiated because of the inadequate protection offered by the boron carbide coating at the periphery. On the other hand, slightly higher edge

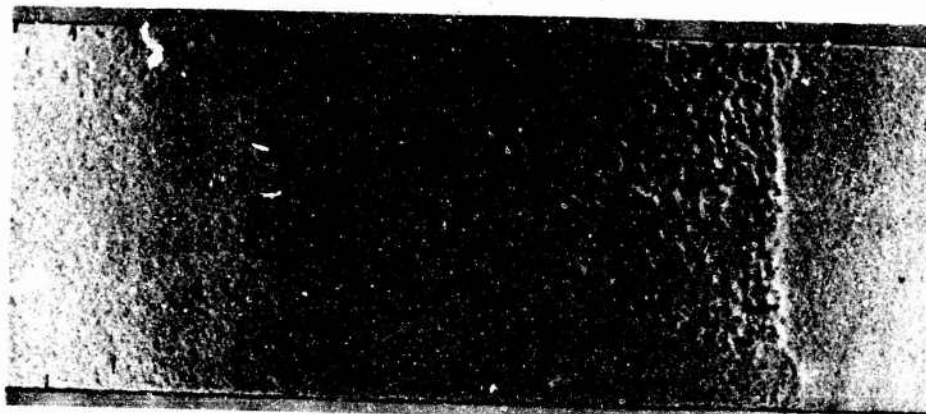
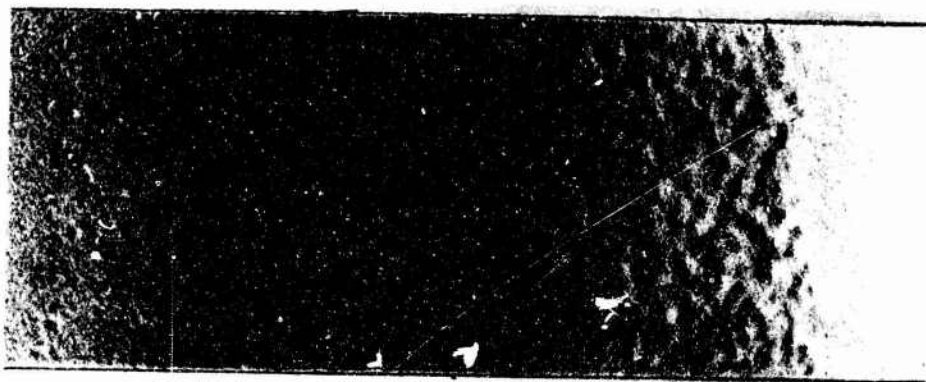
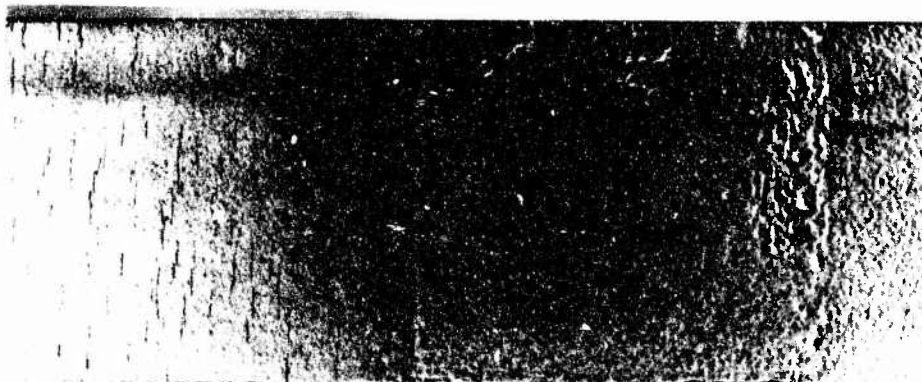
a. (A17) L  
150 Hours

b. (B4) T  
150 Hours

c. (A18) L  
500 Hours

However, no cracks were observed on the non-salted titanium alloy surfaces, nor in the substrate below the major portion of the salt-treated boron carbide coating. Thus, the corrosion-crack-inhibiting potential of this proprietary coating was positively demonstrated on both longitudinal and transverse specimens exposed to a 900°F air environment for 150 and 500 hours.
